SERVICE PROGRAM BULLETIN

APPLICABILITY: 2005 - 2006 MY Subaru Legacy/
Outback 2.5L M/T Turbo

SUBJECT: Radiator Cooling Fan Relay #2

NUMBER: WVB-12
DATE: February 2007

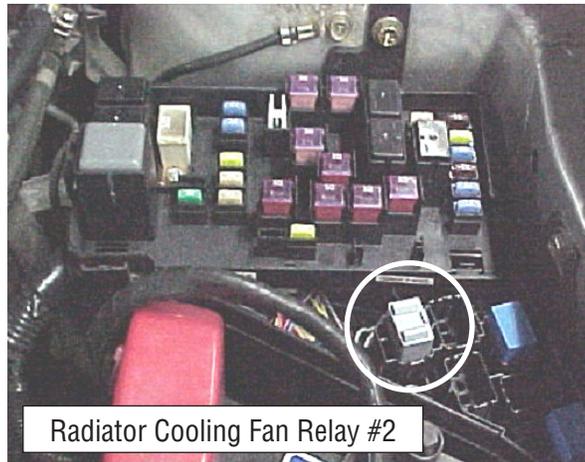
- 1) Turn the ignition switch to the “Off” position.
- 2) Open the hood and locate the main fuse box. Remove the fuse box cover.
- 3) Locate the “Radiator Cooling Fan Relay #2” as pictured below.
- 4) Carefully remove the relay.
- 5) Install a new Radiator Cooling Fan Relay #2.
- 6) Replace the main fuse box cover.

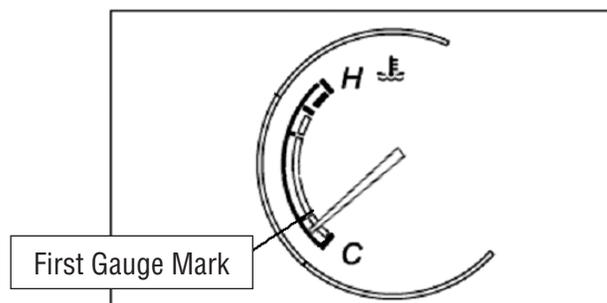
- 1) Ensure the HVAC system is turned to the “OFF” position.
- 2) Ensure the engine coolant temperature is below 196°F. This can be done by checking the engine temperature gauge on the vehicle’s instrument cluster. Confirm the temperature gauge reading is below normal operating temperature—the needle should be between the “C” (cold) and the first gauge mark.

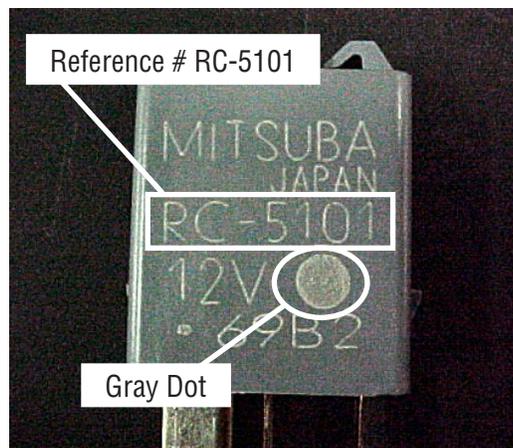
Updated Radiator Cooling Fan Relay #2 (Above) – The updated relay has a gray dot for easy identification; also the reference # has been changed to read, “RC-5101”. The original relay has a different reference # and **no gray dot**.
