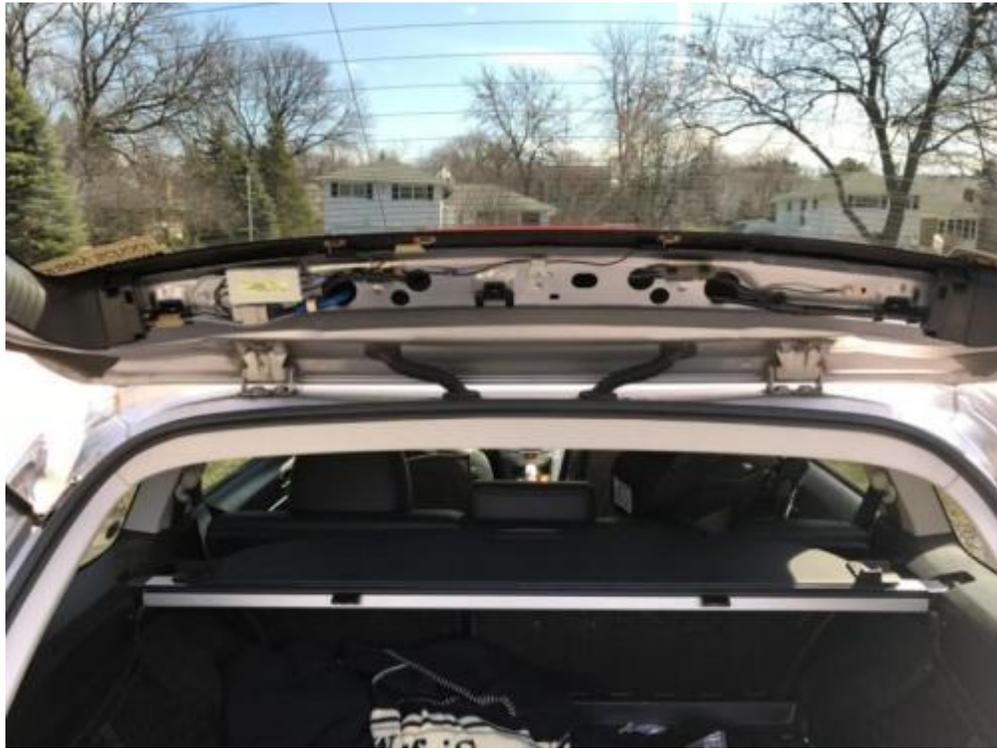
Top interior trim removed

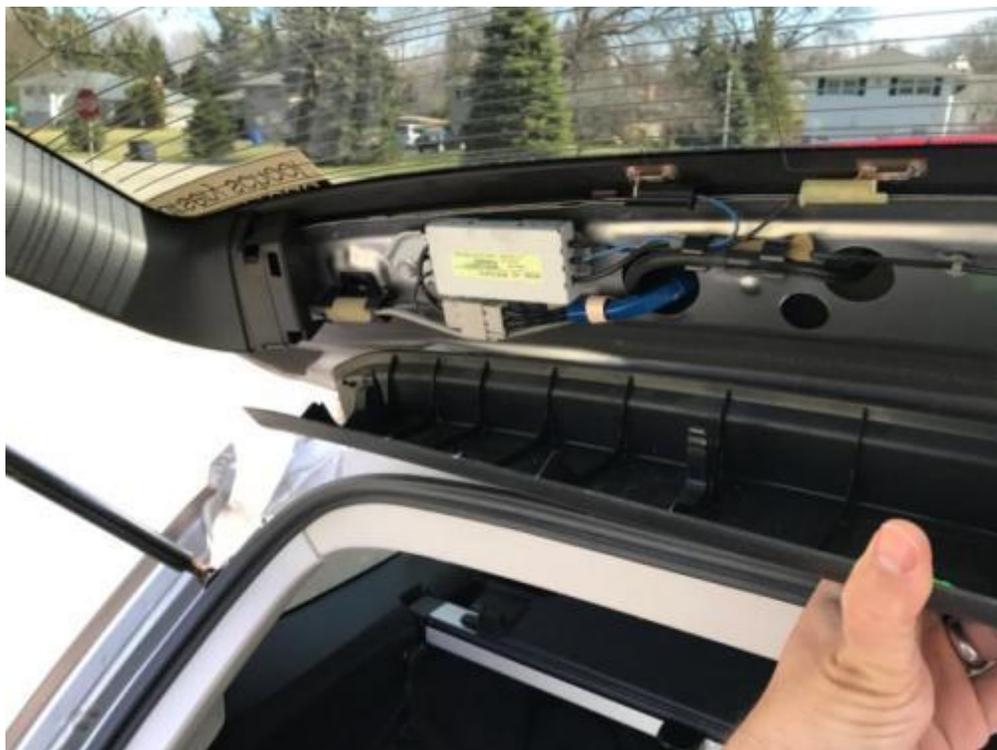
Detail of driver side of top interior trim

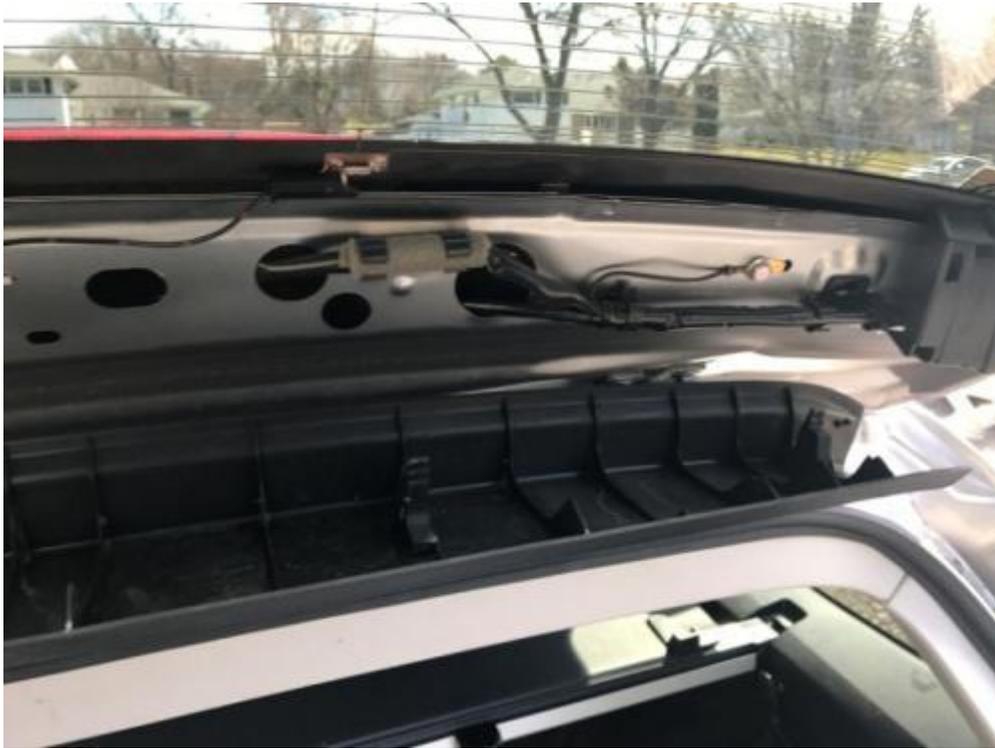
Detail of passenger side of top interior trim

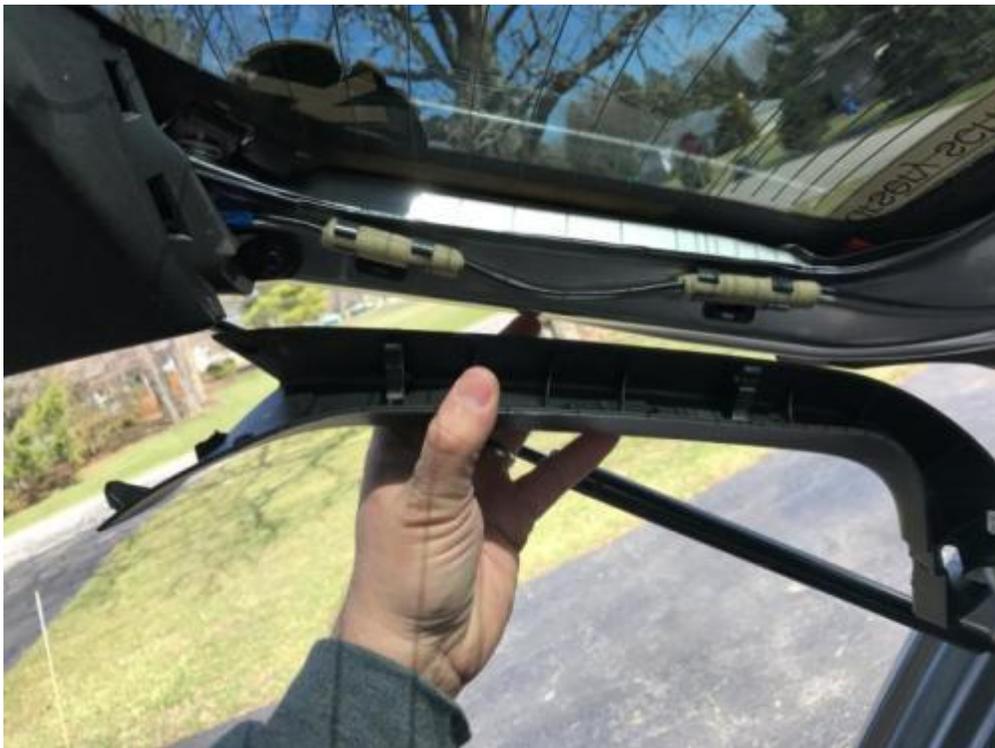
Driver side, side trim.

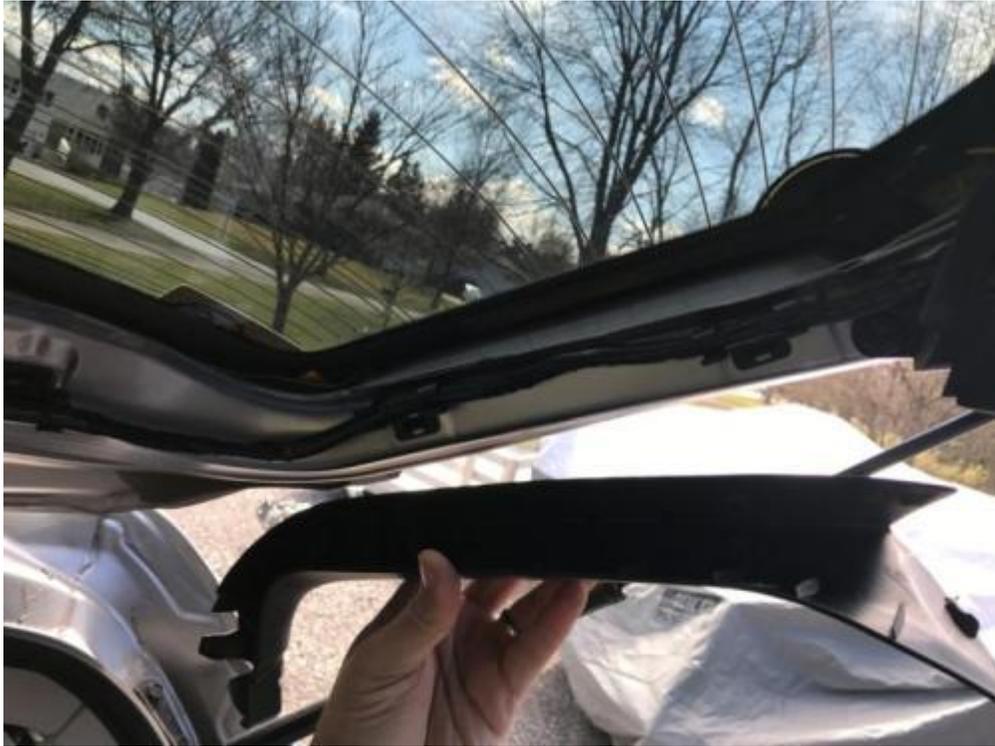
passenger side,side trim

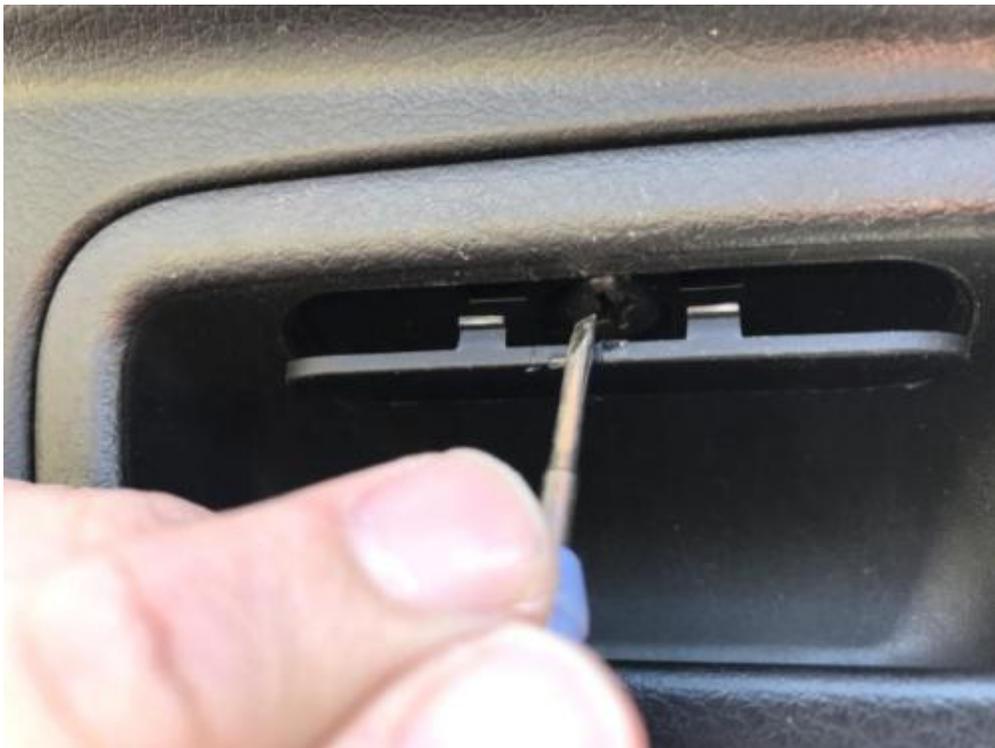
removing cover inside door grab handle

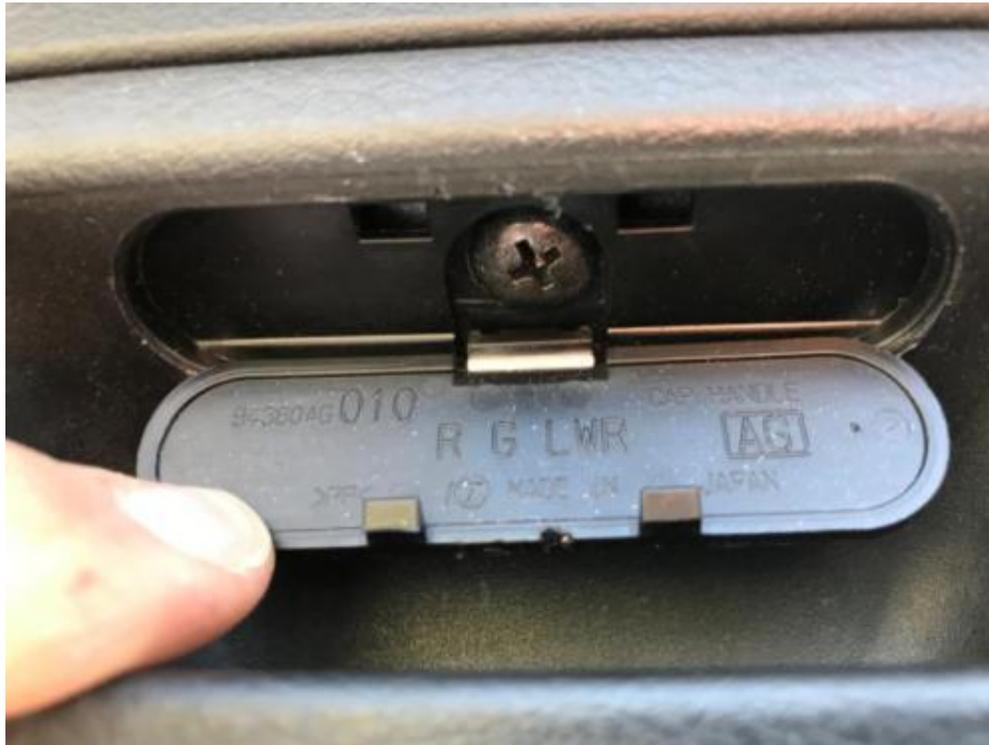
Screw inside grab handle, remove this to release the main interior trim panel

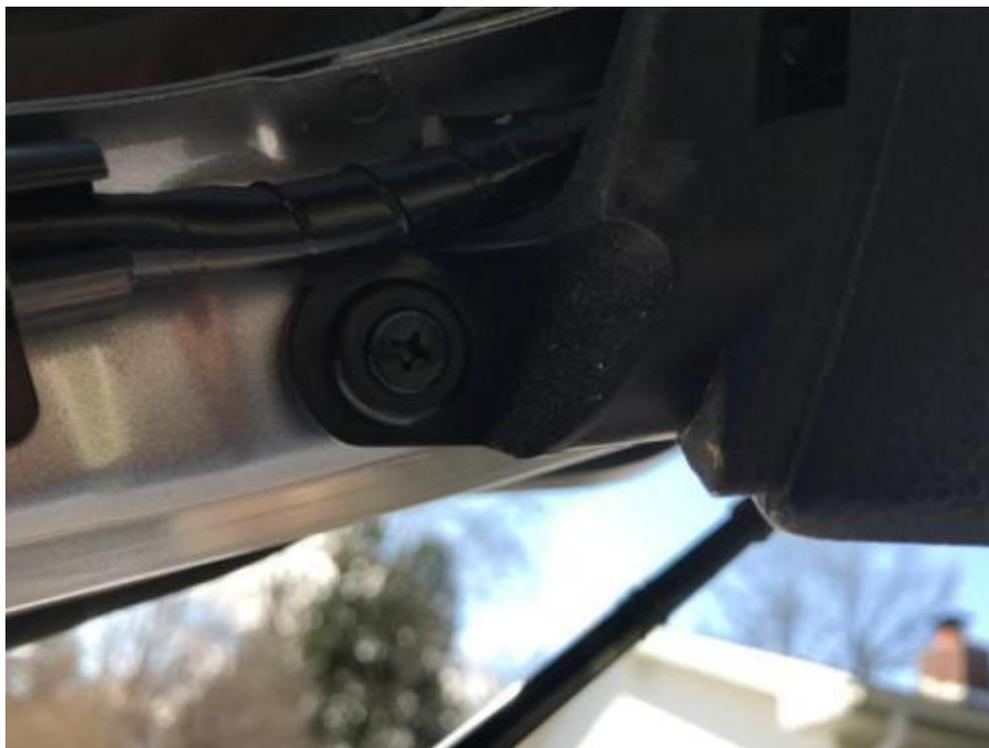
Plastic screw-type pin connector, remove this, one on each side

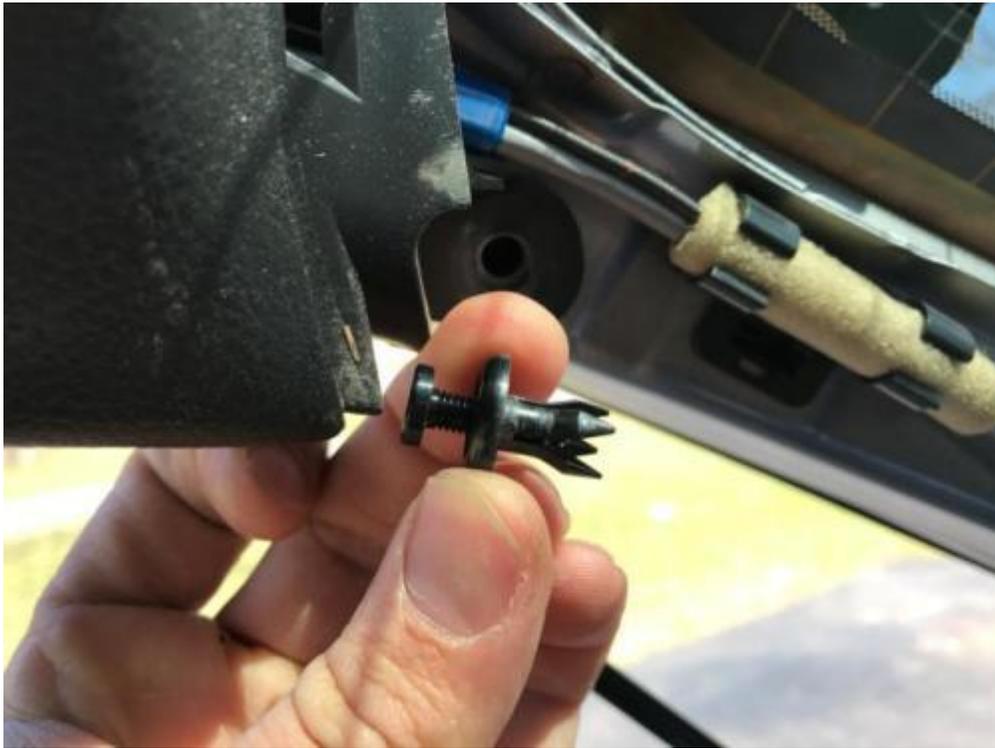
Detail of plastic screw type connector

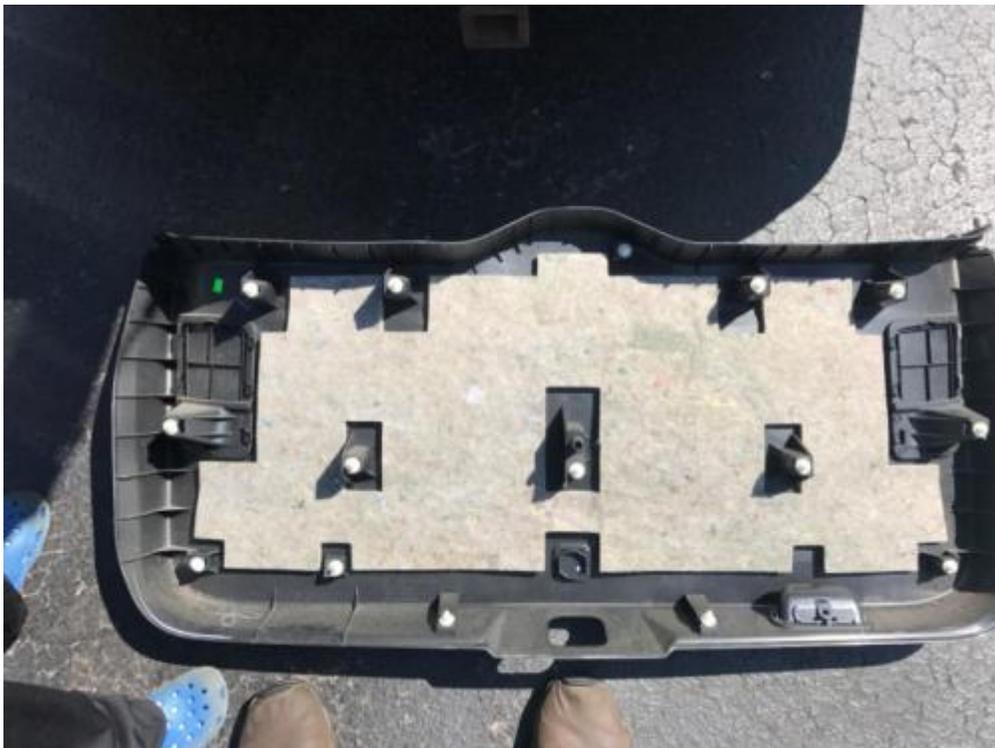
Interior main door panel detail

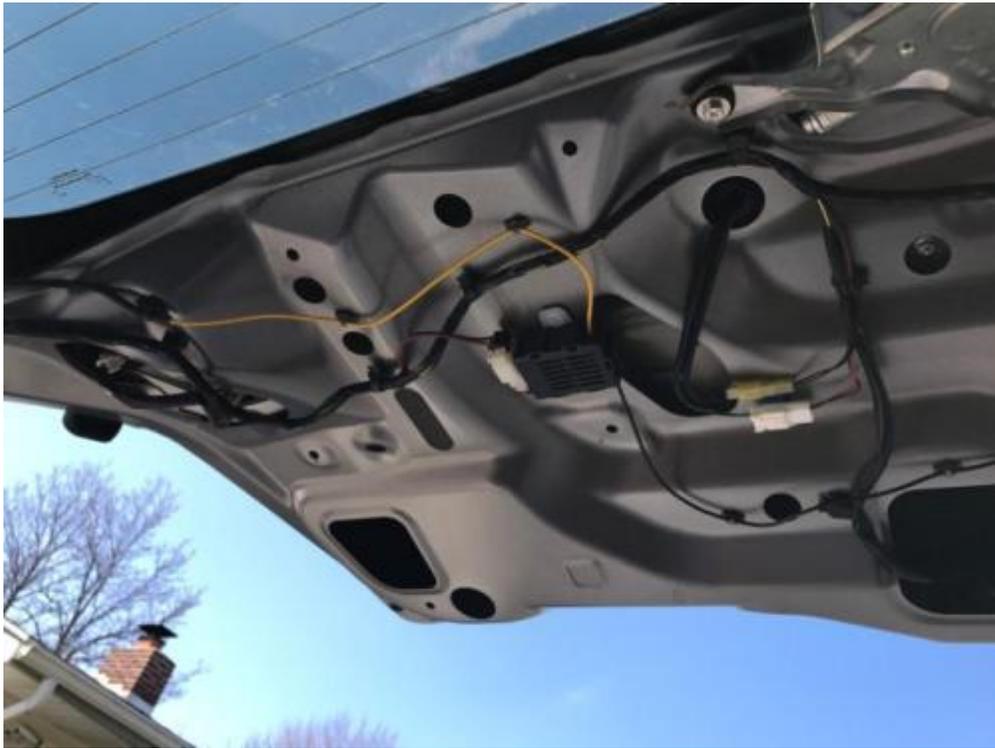
Passenger side interior of lift gate

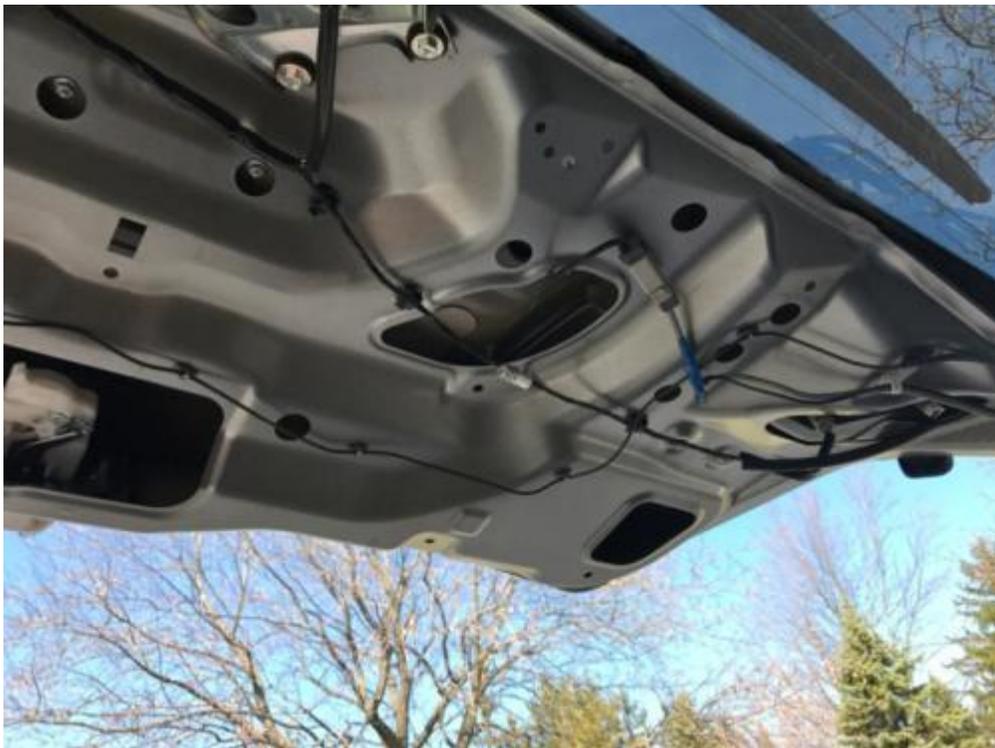
Driver side interior lift gate

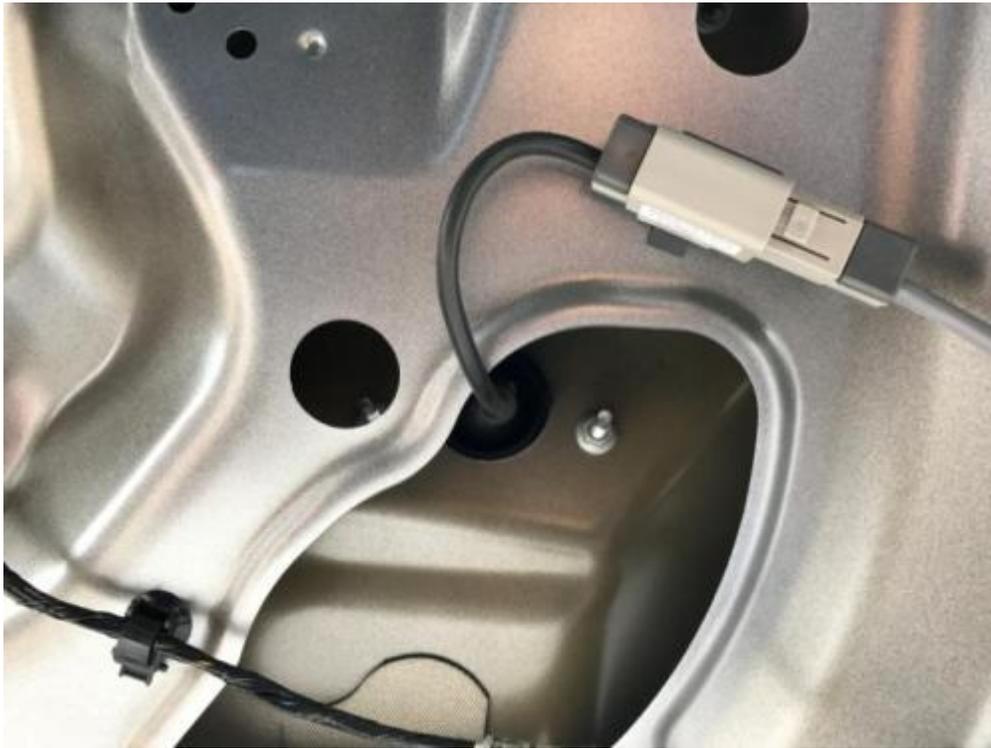
Detail of interior side of reverse camera. Gray connector and two nuts need to be removed, but that is the last step

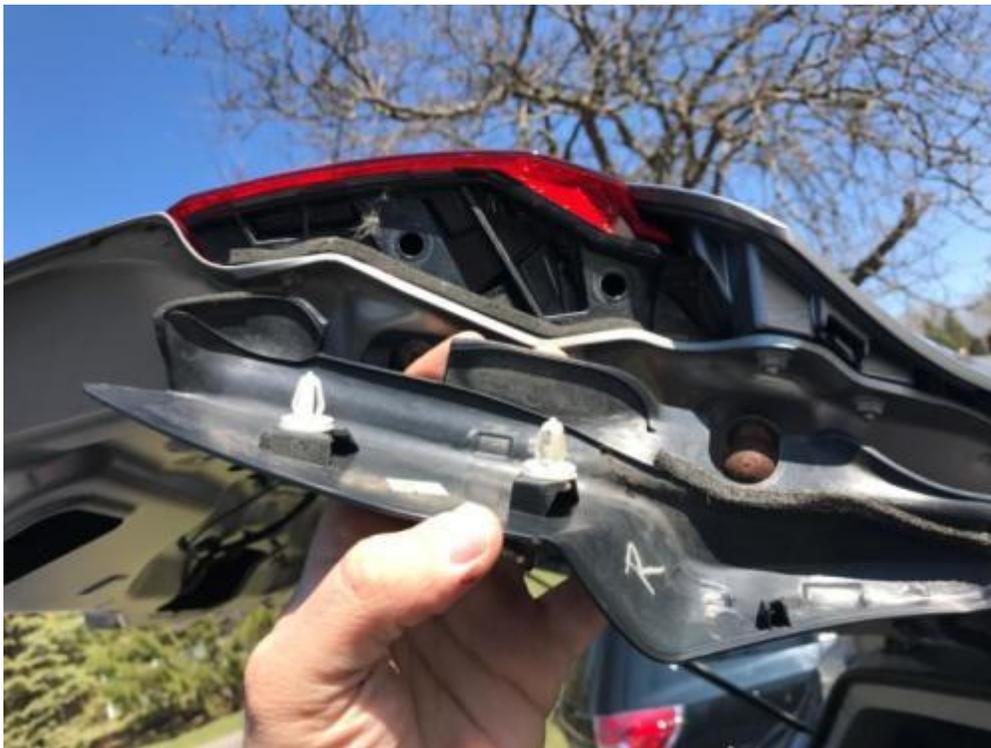
Liftgate side trim, one on each side

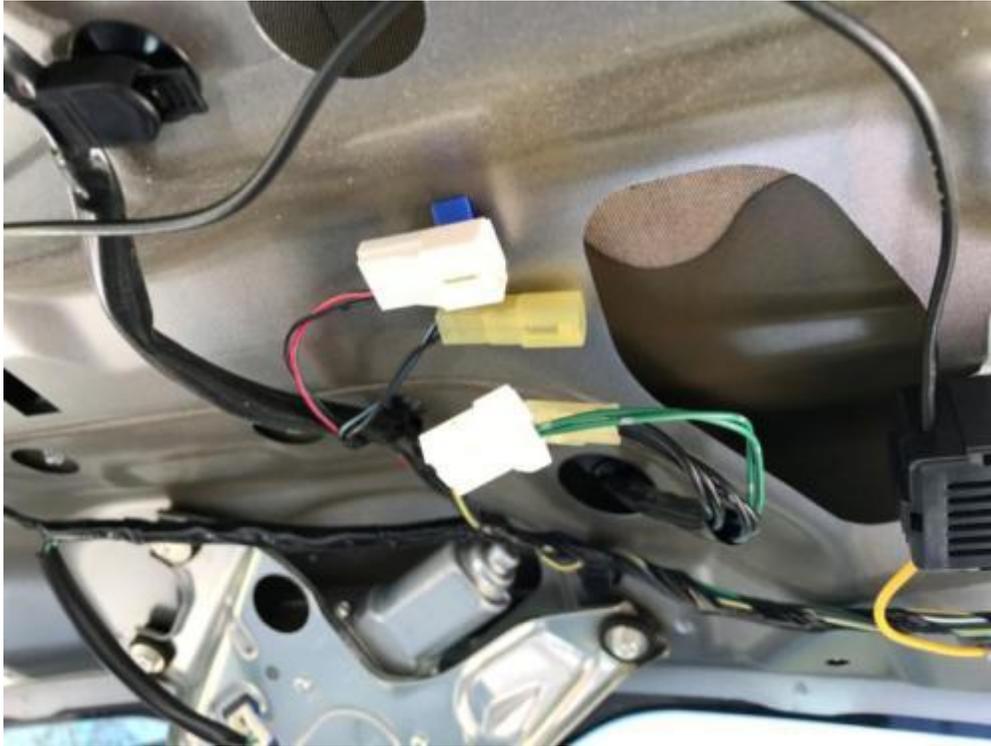
Connectors to be released, green is for door latch, red/black is for license plate lights, they are connected to the exterior trim panel, and will be pulled thru the door.

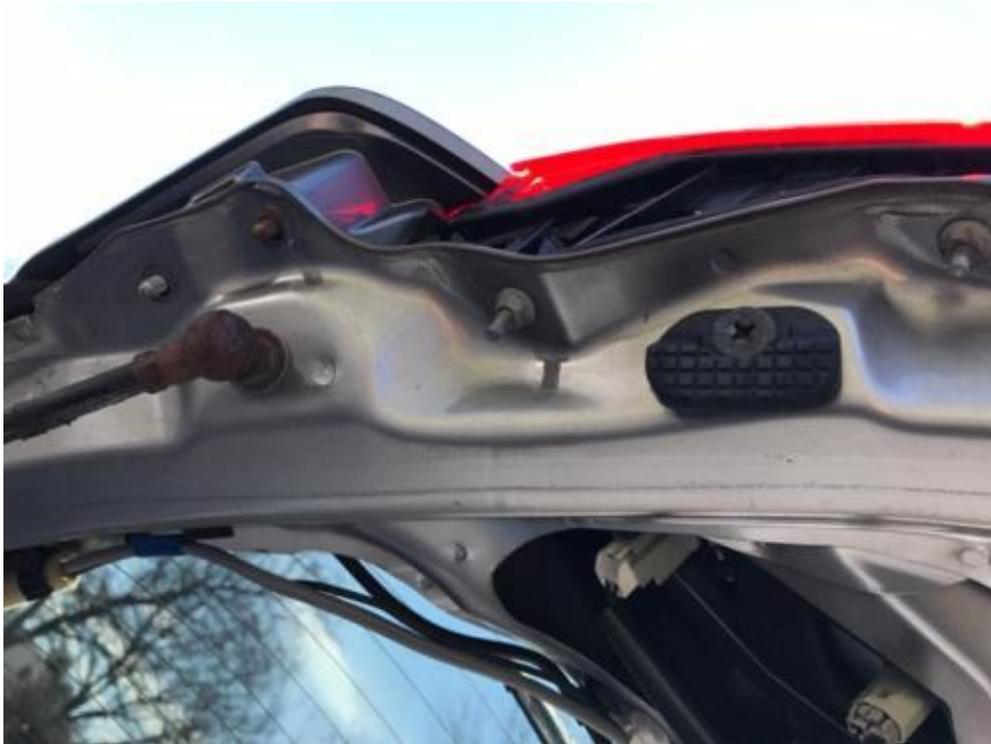
First two nuts removed, above the lift gate strut attachment. same on other side.

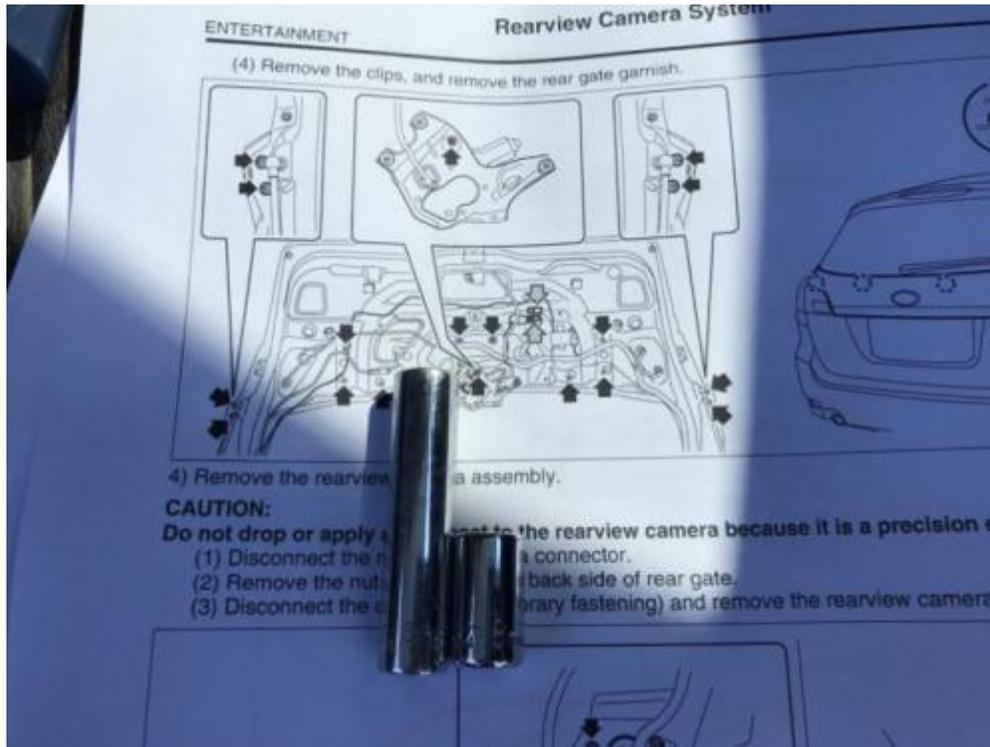
5/16" deep socket needed, 8 mm also works, but there are some bolts that need the deep socket. Sheet behind the sockets is the FSM with bolt removal details. 14 nuts to be removed. some nuts on inner skin of hatch aren't removed, but most are,

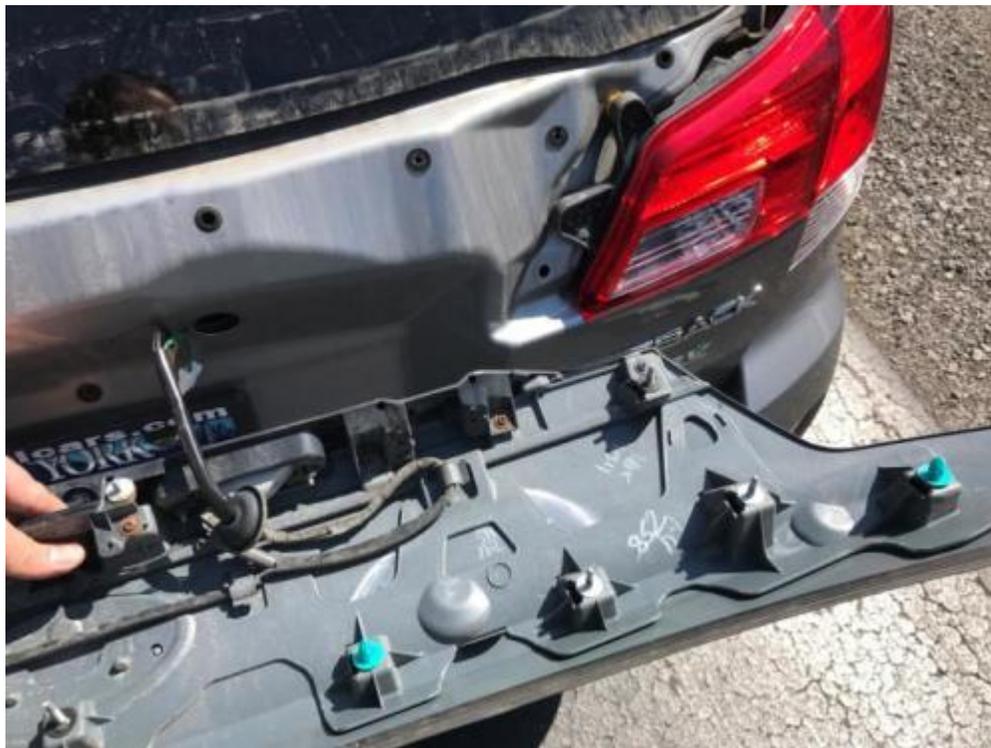
Exterior trim detail, passenger side

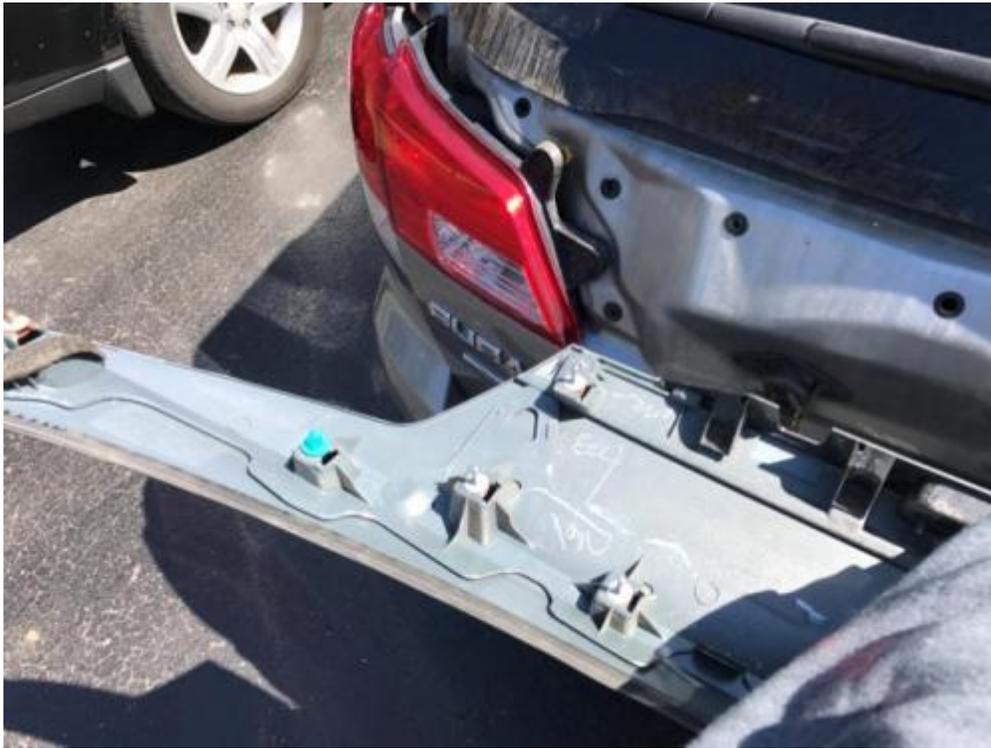
Exterior trim detail, driver side. When removing the trim piece, look down from the top and find the press fit connectors, hold them to the trim piece with your hand and pull. if you just yank the trim piece off you may break it, as the trim assembly is 2 pieces, and the inner piece with the connectors is foam taped to the outer finish piece

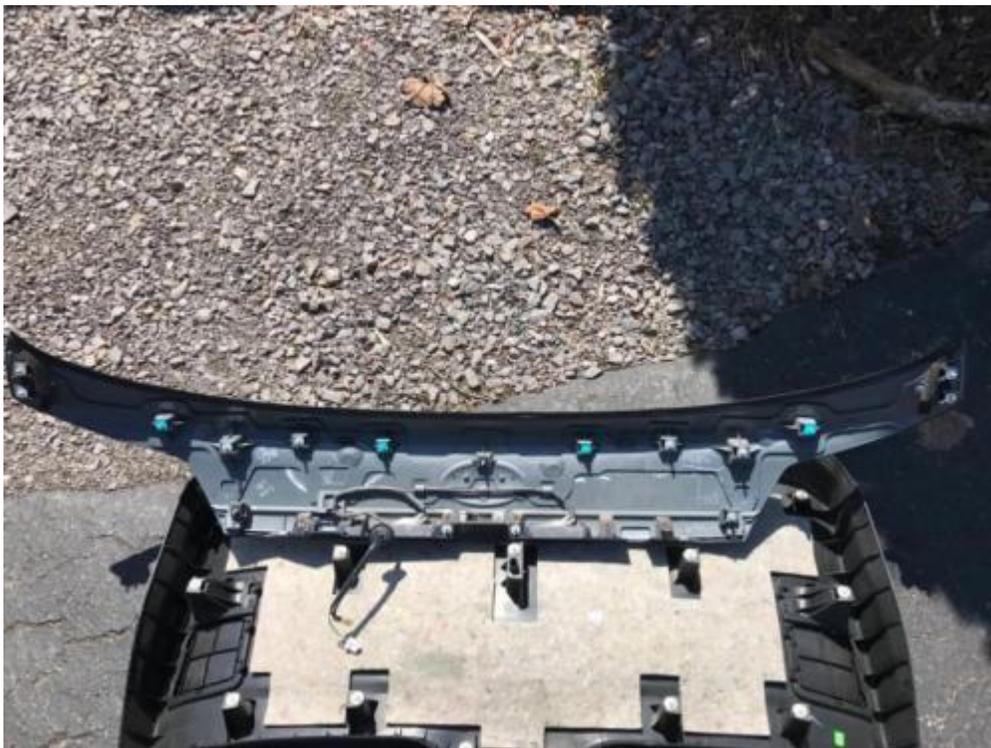
Detail of exterior trim piece

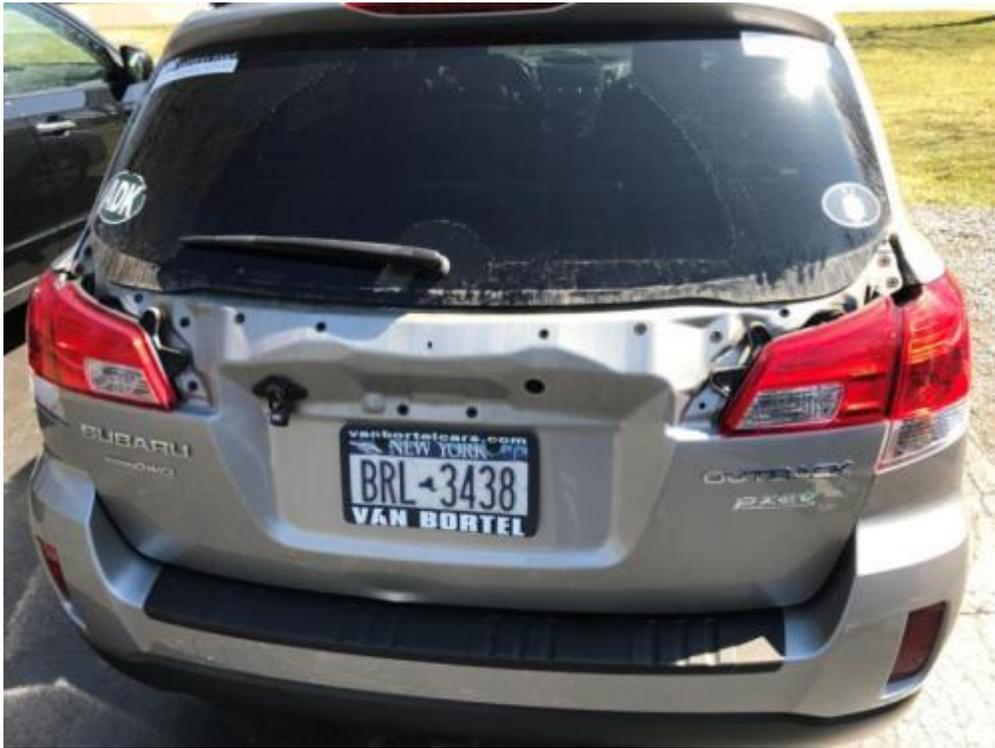
Car with trim piece removed, exposing the camera for replacement

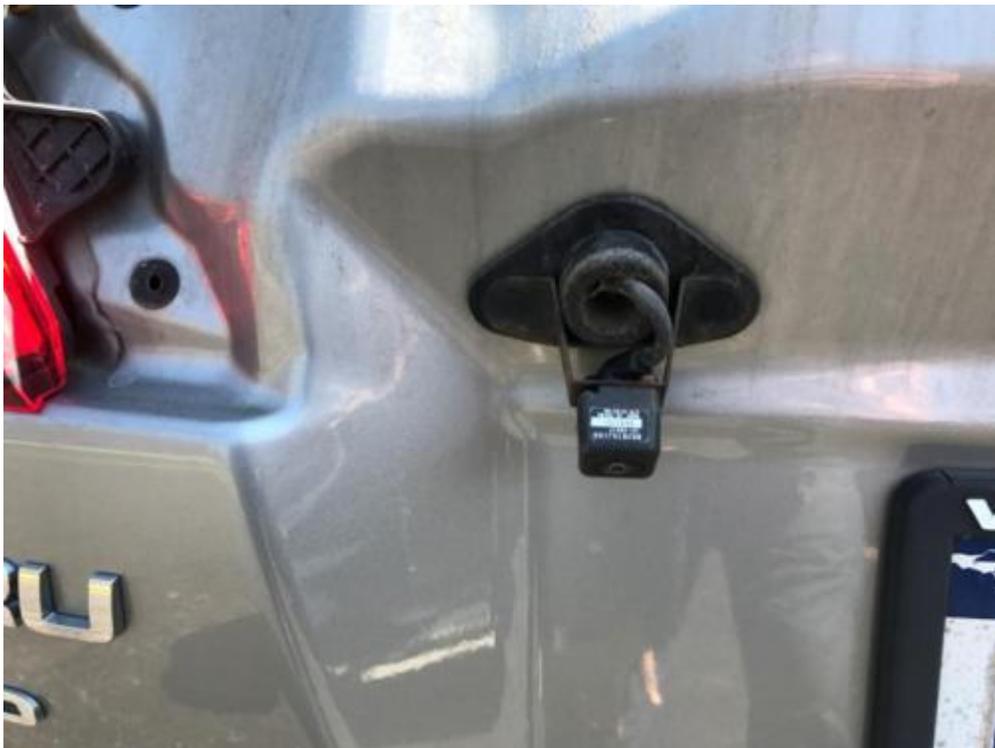
Old cam still mounted

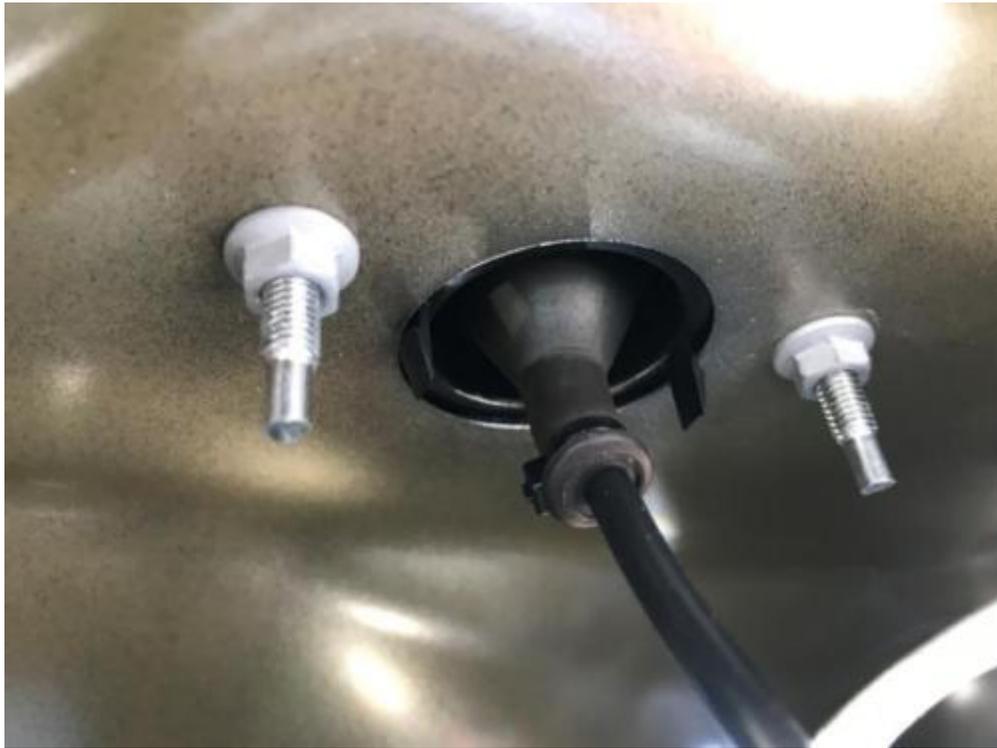
detail of camera mounting interior

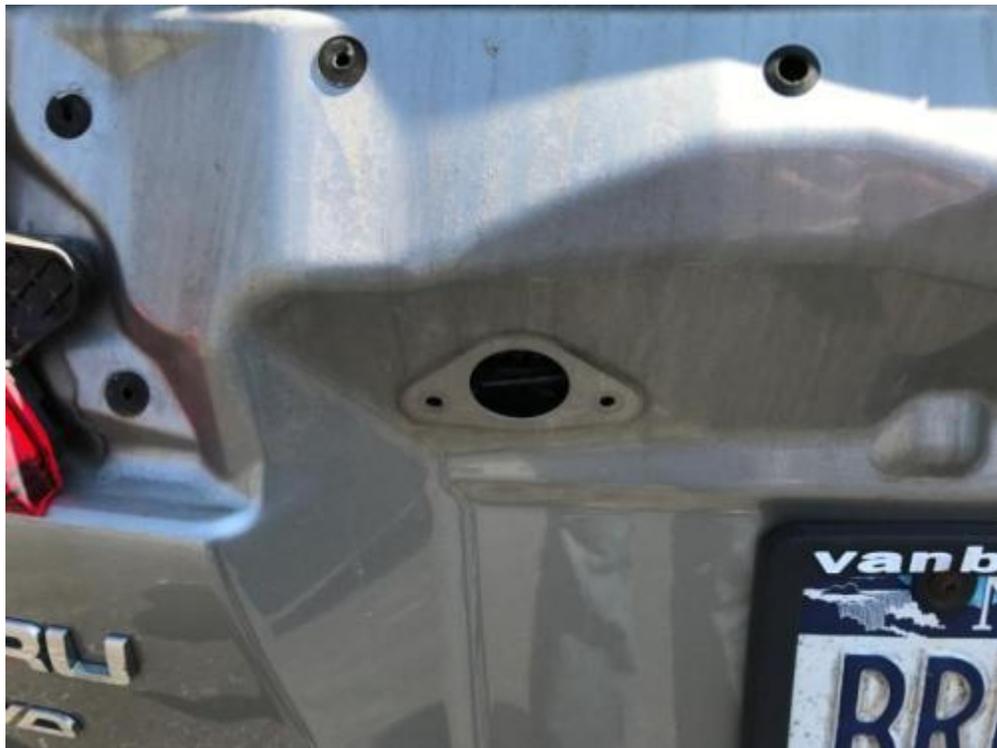
camera removed

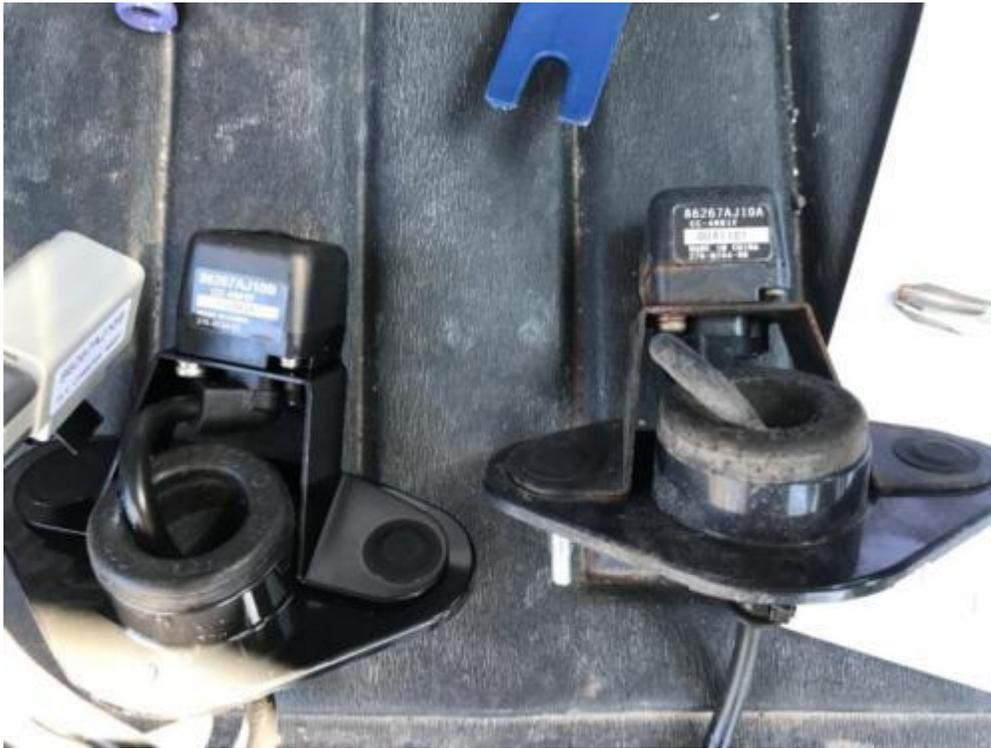
New cam on left, old cam on right. Different part numbers, but same part

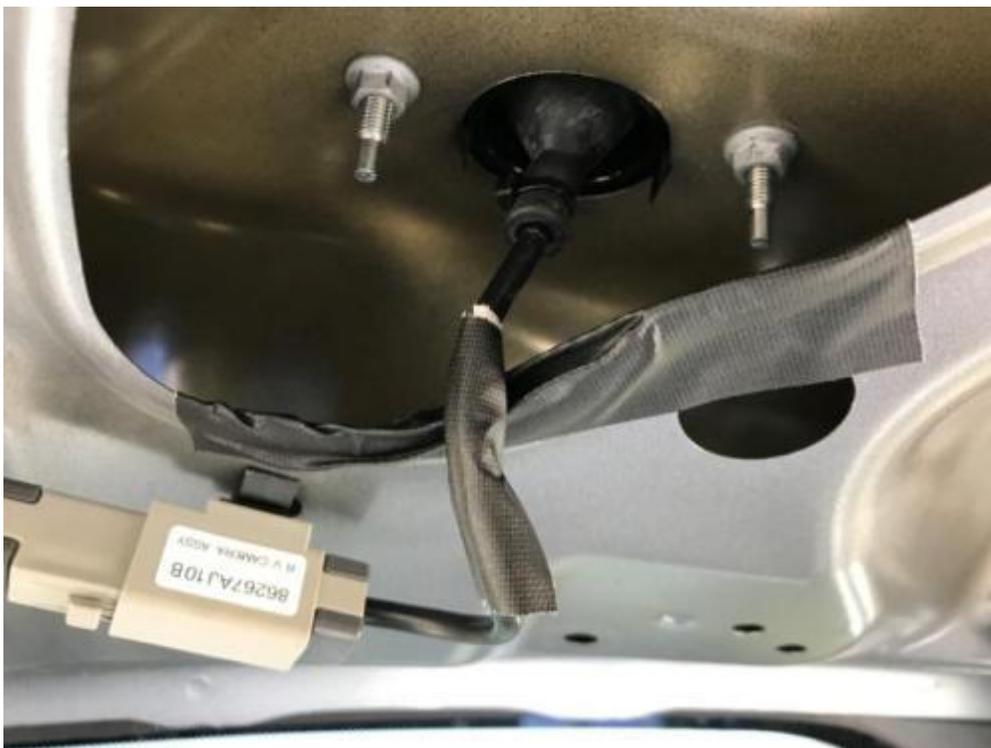
I armored the cable and the edge of the hatch penetration with come tape, seemed sharp to have a cord pressing against it.

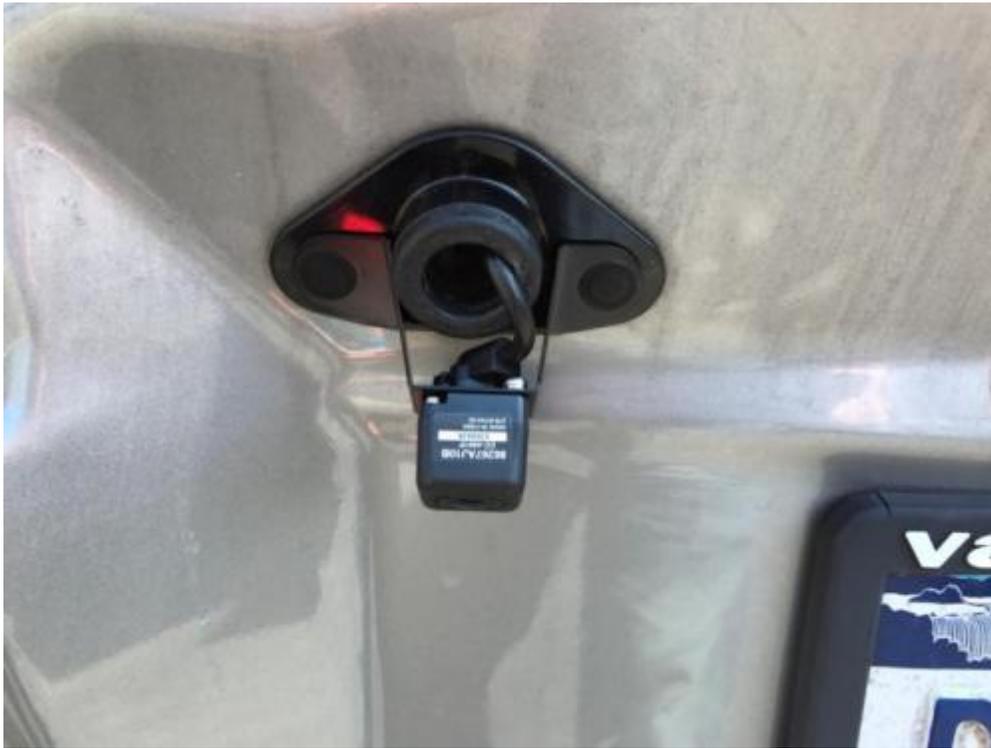
new cam installed

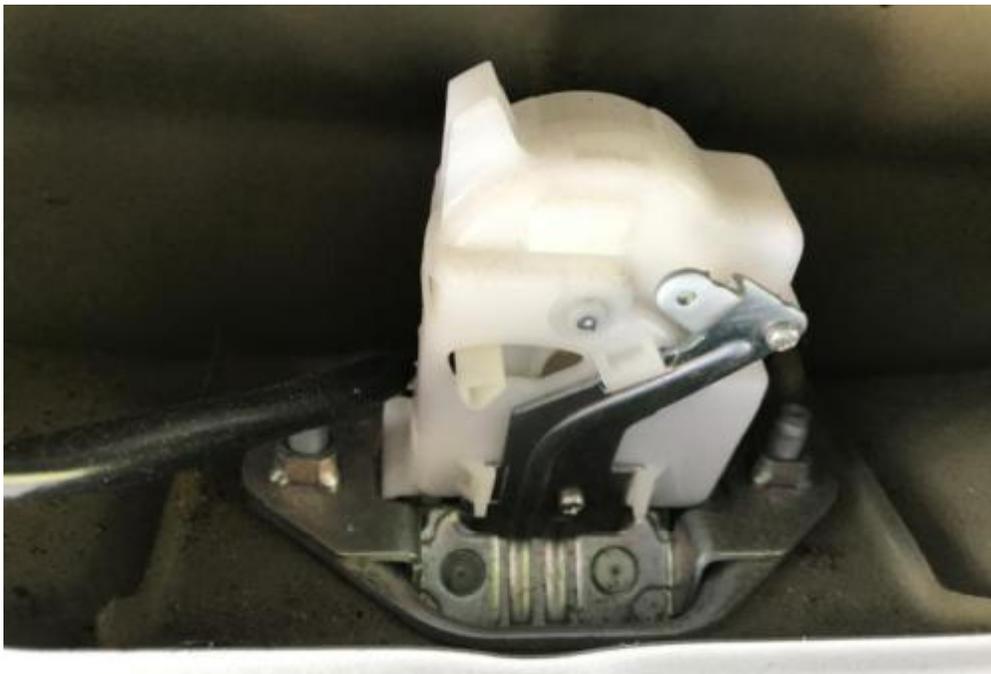
bonus hatch latch picture. when actuating the hatch release, that while plastic lever moved to the right towards the metal arm.

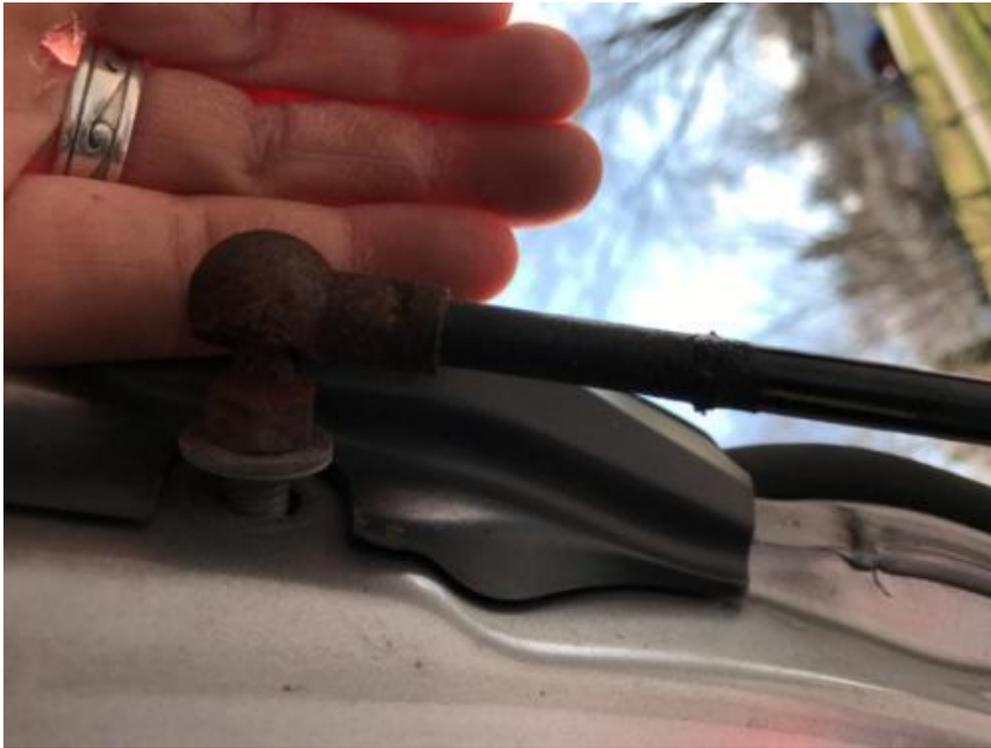
Bonus pic, check your lift struts, discovered my passenger side one was threading itself out over time. the ball threads into the body and can be turned with a 12 mm wrench.
